Water Heater Dip Tubes—Why All the Fuss?

by Danny T. Hutchins, PhD

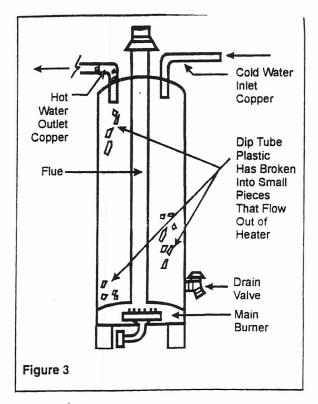
Figure 3 shows that over time, the dip tube continues to change. Cracks and fractures form all over the dip tube surface. The turbulence created inside the tank breaks the tube into increasingly

smaller pieces. The pieces are eventually flushed out of the tank through the hot water outlet. The missing dip tube also reduces the supply of hot water.

1. Flush the debris from the heater tank, install a new dip tube, and flush the strainers and aerators. In order to flush the heater tank, a fullport drain valve has to be installed for each heater. In the case of the apartment complex, the approximate cost to flush the heater and replace the dip tube was \$280 to \$300 per unit. It took 45 minutes to an hour to clean all the strainers, aerators, and fixtures in one apartment.

2. Replace the water heater and clean and flush the strainers and aerators. The cost of this method was projected at \$450 to \$500.

Regardless of the approach you use, the fixtures, strainers, and aerators will have to be cleaned over and over until all of the small pieces of the dip tube are flushed from the distribution piping.
